## Windstorm Mitigation Report

Surfside Tower Condominium

Madeira Beach, FL

As of 03-20-2026 | FPAT File# VAL2626505

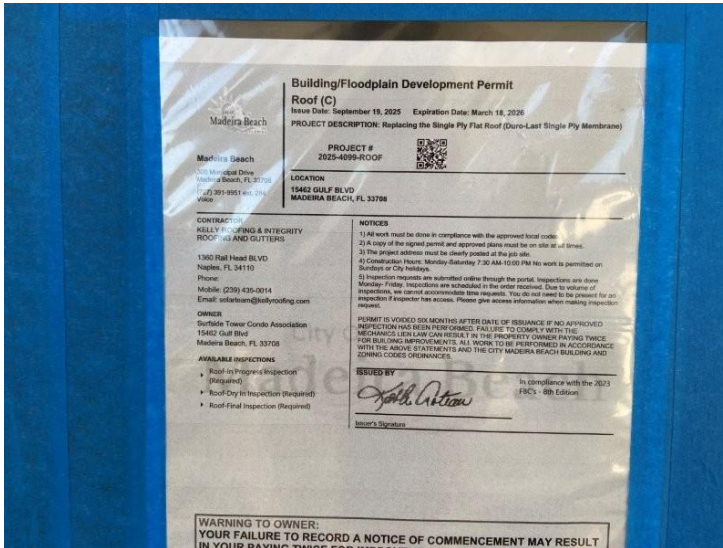
Roof Permit Information

- 2. Roof Covering:** **FBC Equivalent**  
Comments: The roof covering was replaced in 2025. The roof permit was confirmed and the permit number is 2025-4099-ROOF. This roof was verified as meeting the building code requirements outlined on the mitigation affidavit.

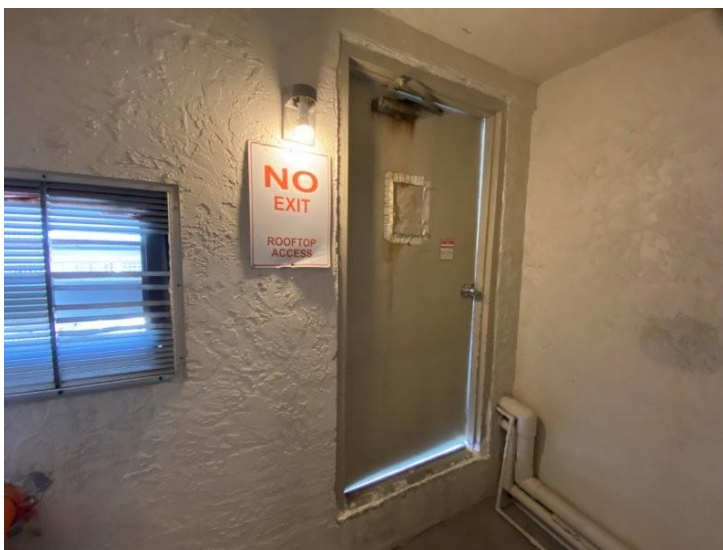
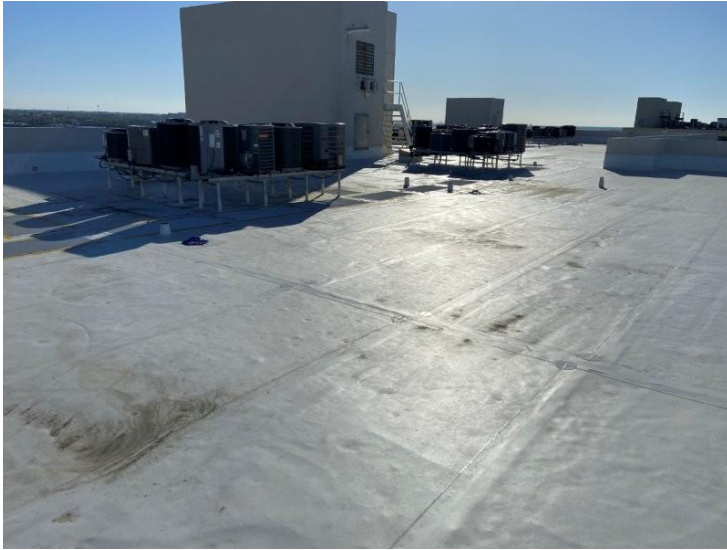
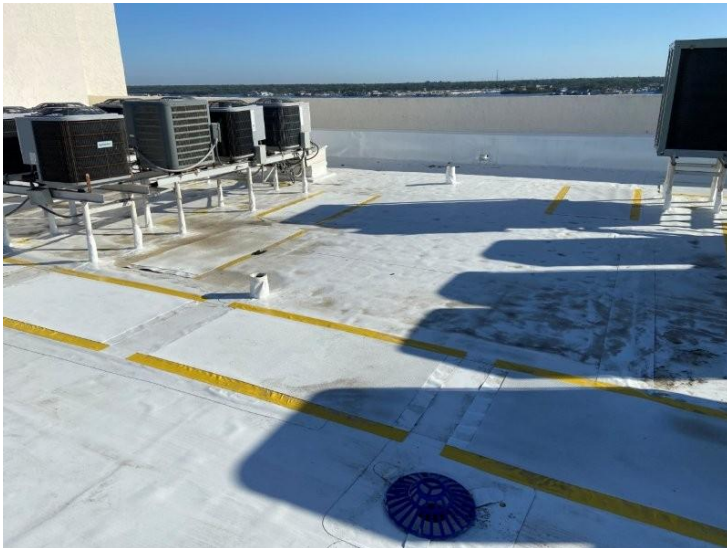
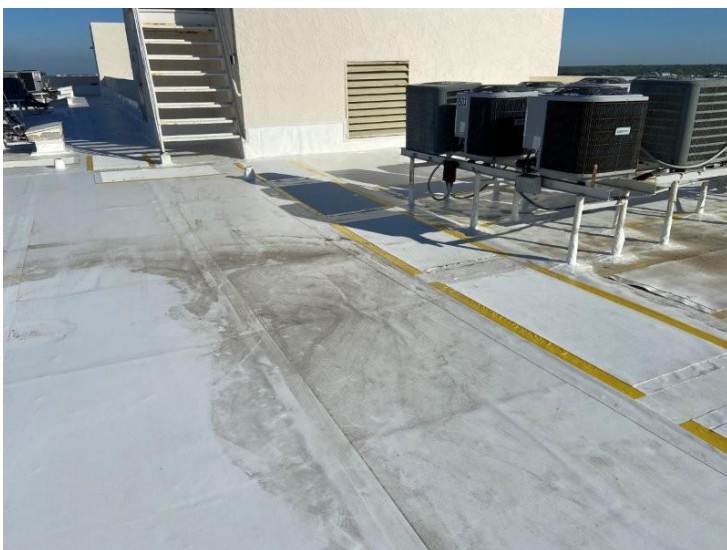
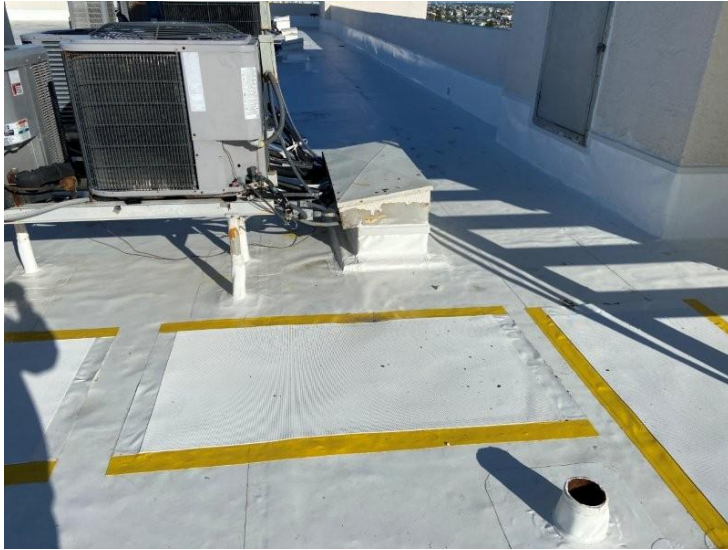
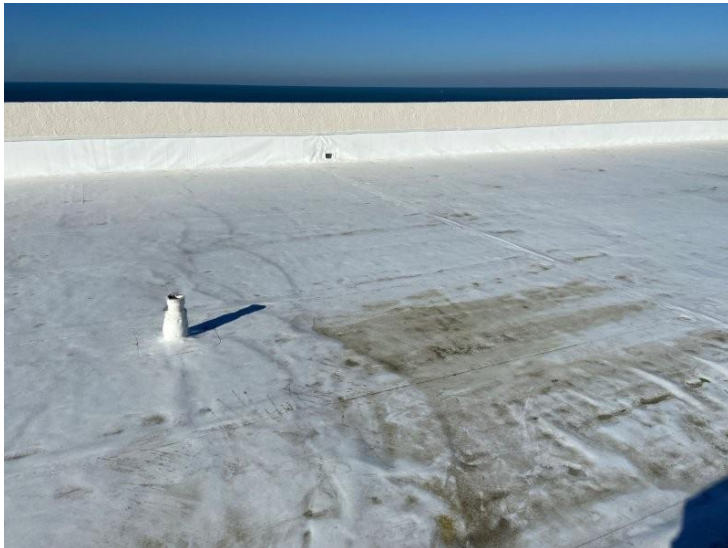
Roof Construction

- 3. Roof Deck Attachment:** **Reinforced Concrete Roof Deck**  
Comments: Inspection verified a roof structure composed of cast-in-place or pre-cast structural concrete designed to be self-supporting and integrally attached to the wall / support system.

- 4. Roof to Wall Attachment:** **Structural**  
Comments: Inspection verified a roof structure composed of cast-in-place or pre-cast structural concrete designed to be self-supporting and integrally attached to the wall / support system.

- 5. Roof Geometry:** **Flat Roof**  
Comments: Inspection verified flat roof shape, refer to attached photographs.
- 6. SWR:** **No**  
Comments: SWR does not apply to reinforced concrete roof decks.

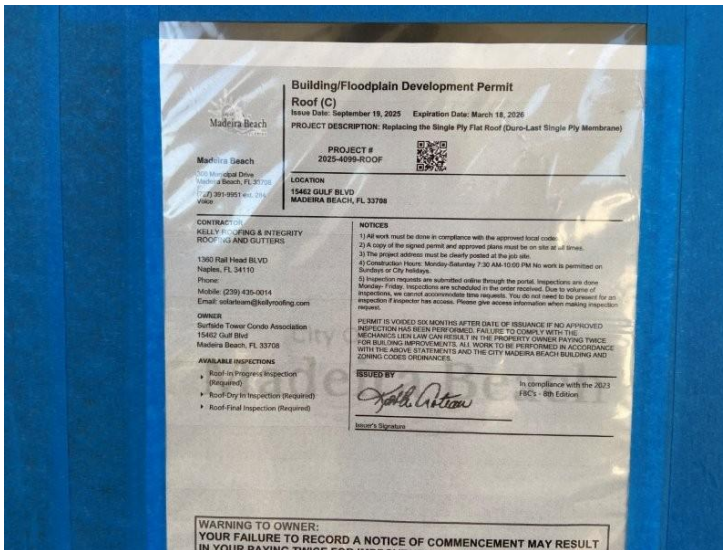
Roof Permit Information

- 1. Roof Covering:** **FBC Equivalent**  
Comments: The roof covering was replaced in 2025. The roof permit was confirmed and the permit number is 2025-4099-ROOF. This roof was verified as meeting the building code requirements outlined on the mitigation affidavit.
- 2. Roof Deck Attachment:** **Reinforced Concrete Roof Deck**  
Comments: Inspection verified a roof structure composed of cast-in-place or pre-cast structural concrete designed to be self-supporting and integrally attached to the wall / support system.
- 3. SWR:** **No**  
Comments: SWR does not apply to reinforced concrete roof decks.
- 4. Opening Protection:** **None or Some Glazed Openings**  
Comments: Inspection verified some opening protection. Not all glazed openings were protected with impact resistant coverings.
